Park Inventory, Assessment & Analysis

LEVEL OF SERVICE (LOS)

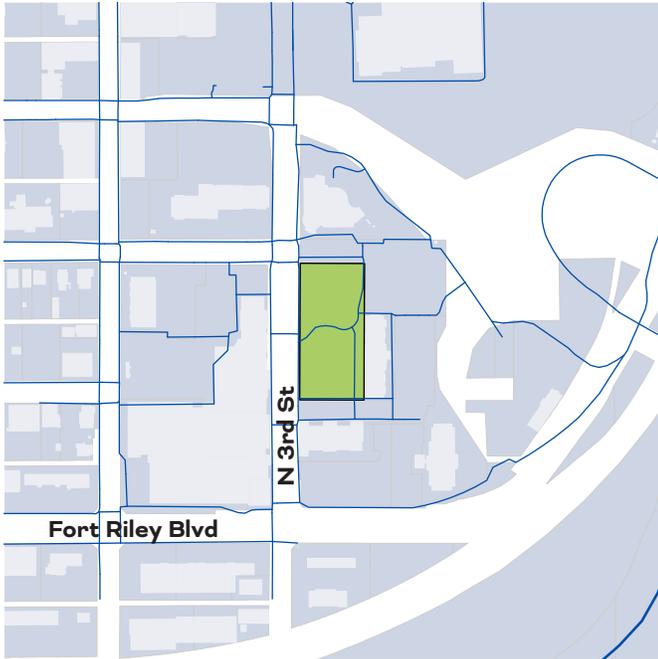
Blue Earth Plaza

Blue Earth plaza is in excellent condition. The park seems well maintained and there are minimal signs of heavy use.

- Consider adding a small stage and shelter to utilize the open lawn area
- Add a park system sign
- Budget for future concrete repairs
- Water Feature: Leaper Renovation
- Plaza: Renovations (20 years)

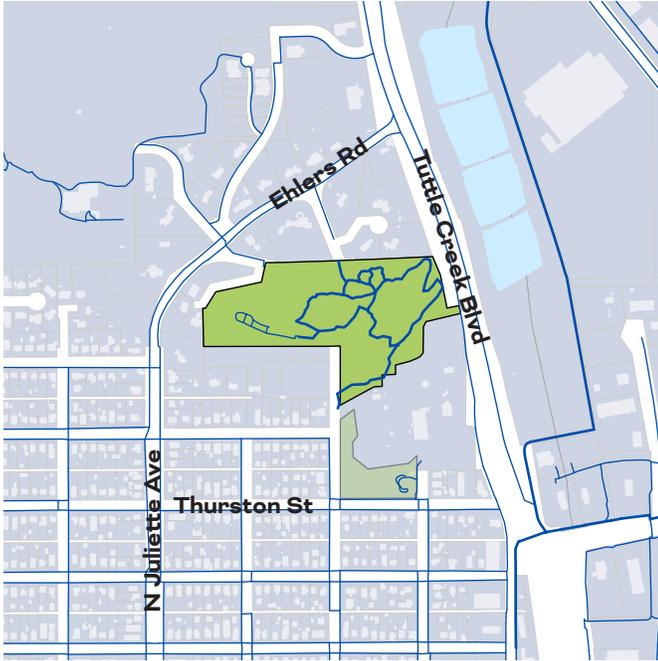
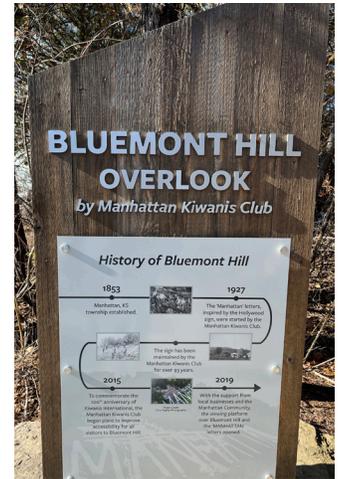
Bluemont Hill Scenic Overlook

The condition of amenities in this park is fairly poor. Although the observation deck is in brand new condition, the trails are dangerously steep and vegetation needs clearing. The youth cabin on the south side of the park has graffiti on the back and there is a dangerous stone remnant along the side of the hill covered in graffiti.

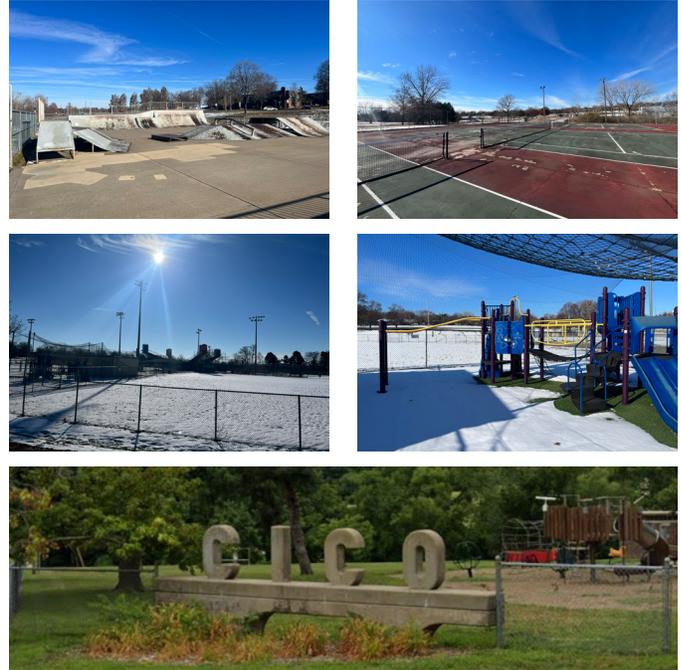
CiCo Park

All amenities at this park are in poor condition. There are signs of heavy use. The skate park is rusted, the tennis courts are cracked and eroding, and the chains of the baseball fields are warped.

Amenities are not well connected between each other. Concrete pavement is cracked and may need attention in the next year. Skate park looks to be in severe neglect and decay. All park amenities look aged and need general maintenance and repair. Repair sidewalks and add lighting. Continue to increase and enhance trail connections throughout this park and the system as a whole.

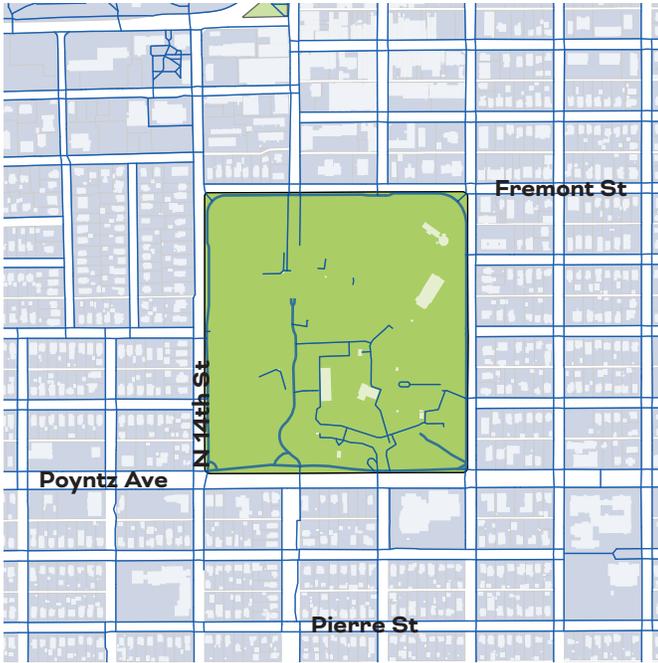
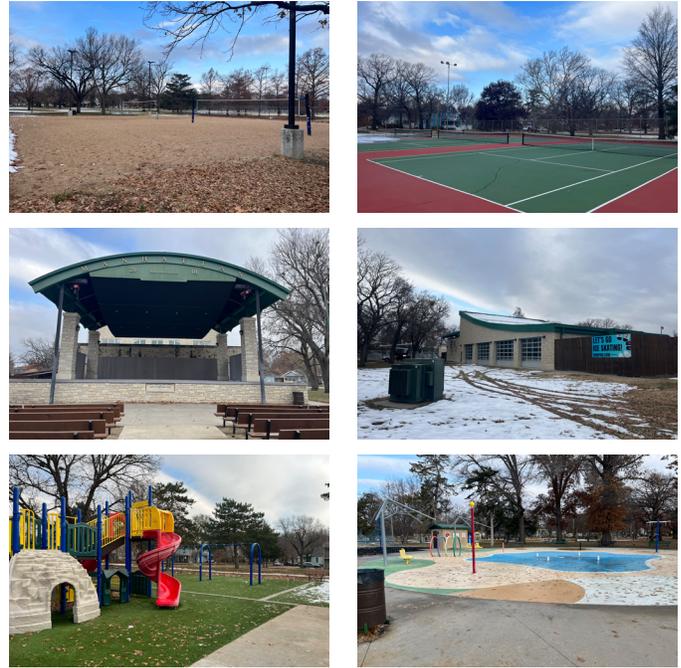
Most of the amenities in City Park are in great condition and appear well maintained. The amenities that are in most need of improvement are the sports amenities such as baseball, basketball, and sand volleyball.

Most buildings need some minor repairs. Minor repairs may include: tuck pointing, painting, sealing, trim repair, replacing wood with rot, general maintenance or cleaning. The dance studio/Round House and the Administration building need immediate tuck pointing and stone repair, with the latter having possible settlement at NE corner.

Wayfinding is difficult around the park. Not a very cohesive design in regards to circulation and amenity placement. Not enough ADA parking or picnic shelters. Some of the sidewalks are degrading and do not connect to a lot of the amenities in the interior of the park.

- Paint pool
- Stingray deck phase 2
- Improve central park amenities
- Replace bubble slide
- Irrigation improvements
- New nature playspace
- Paint pool 2032-2034

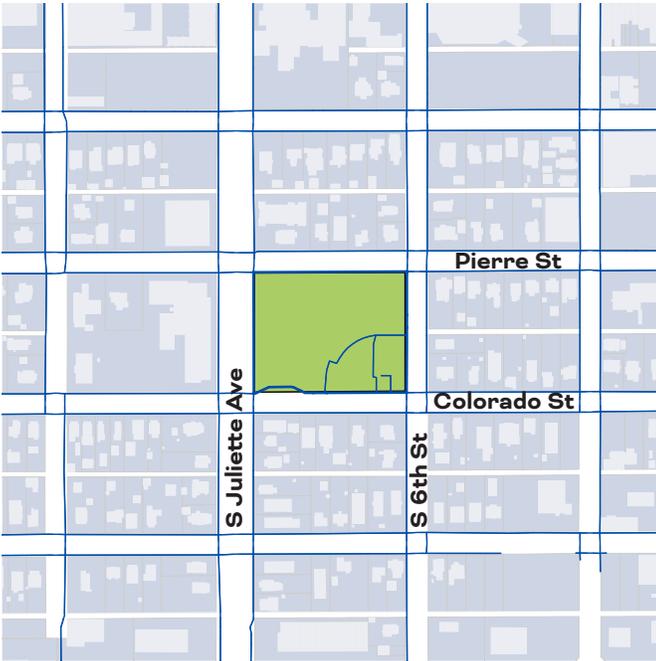
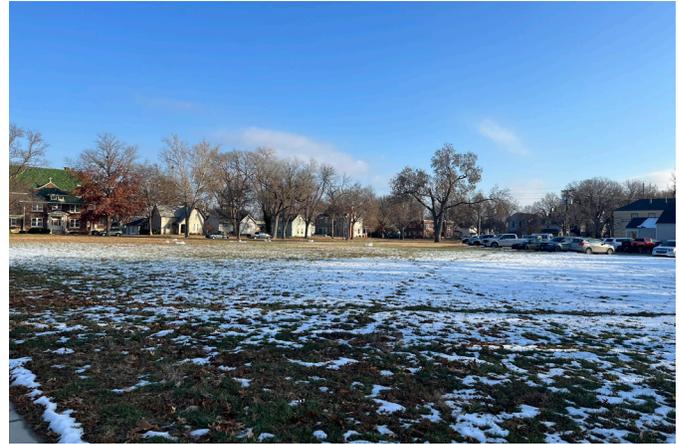
The site furnishings and pavement that Colorado Park has are in excellent condition and appear to be well maintained.

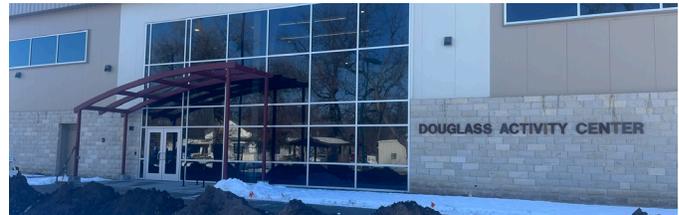
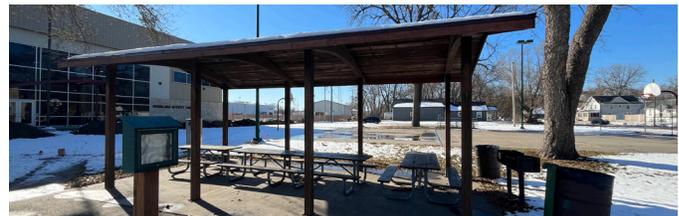
Douglass Park

The shelter is in general good condition but may have long-term degradation concern for column bases. The Annex and the Douglass Activity Center are not new, but have been well maintained over the years and appears to be in good condition. The activity center may need some minor repairs to some siding and trim.

The playground and the shelter are in good condition and will most likely need repair in the next five to ten years. However, the basketball court has signs of use and will need to be replaced and resurfaced sooner.

Basketball court appears to use tape to stripe the court, consider painting. Sidewalks have cracks and may need repair. Parking is limited or street only. There is no park signage.

- Add park signage
- Re-stripe basketball court
- Repair sidewalks
- Parking lot improvements
- Replace playground surfacing
- Add lighting

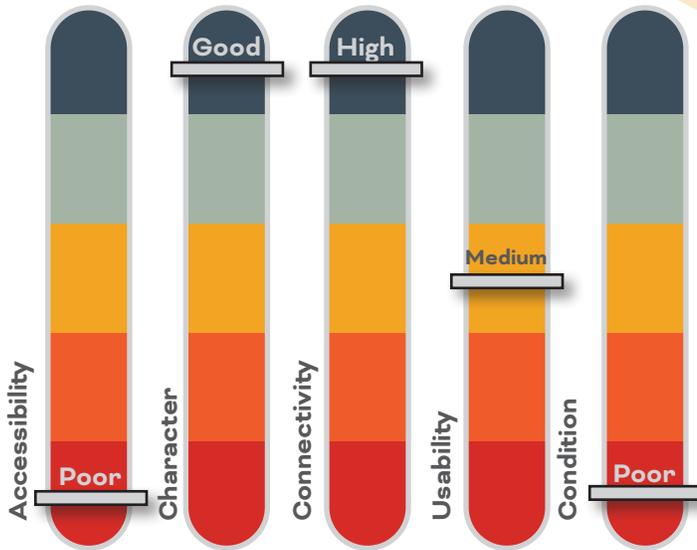
BUILDING ASSESSMENT

The Girl Scout House needs general maintenance, tuck pointing, sealant, window repairs/replacement, trim repair, cleaning, and painting. The pavilion base is in good condition but the decorative facade on the south side is in need of immediate repair attention.

- Update existing amenities like the picnic tables in the next 5 years
- Consider adding picnic shelters where the picnic tables are
- Parking lot improvements
- Repair and replace all elements listed in building assessment

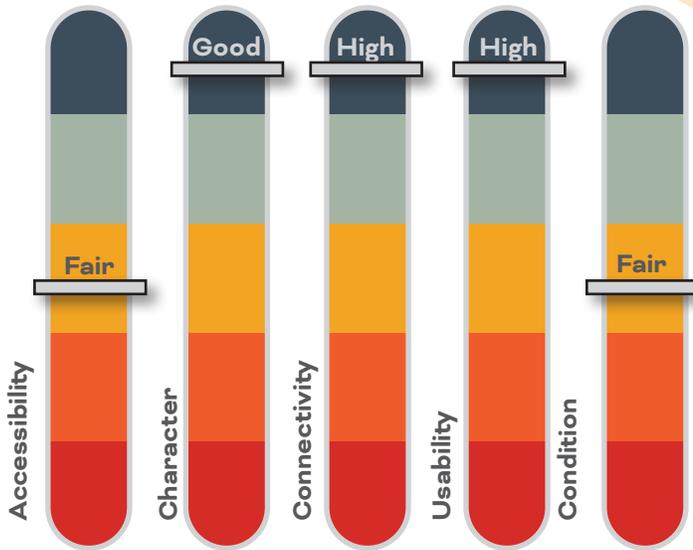
BUILDING ASSESSMENT

The shelter is in general good condition and just needs some trim repairs and paint.
